# RAAD VOOR DE LUCHTVAART

## FINAL REPORT

OF THE INVESTIGATION INTO THE ACCIDENT WITH THE COLLISION  
OF KLM FLIGHT 4805, BOEING 747-206B, PH-BUF AND  
PAN AMERICAN FLIGHT 1736, BOEING 747-121, N736PA  
AT TENERIFE AIRPORT, SPAIN ON 27 MARCH 1977

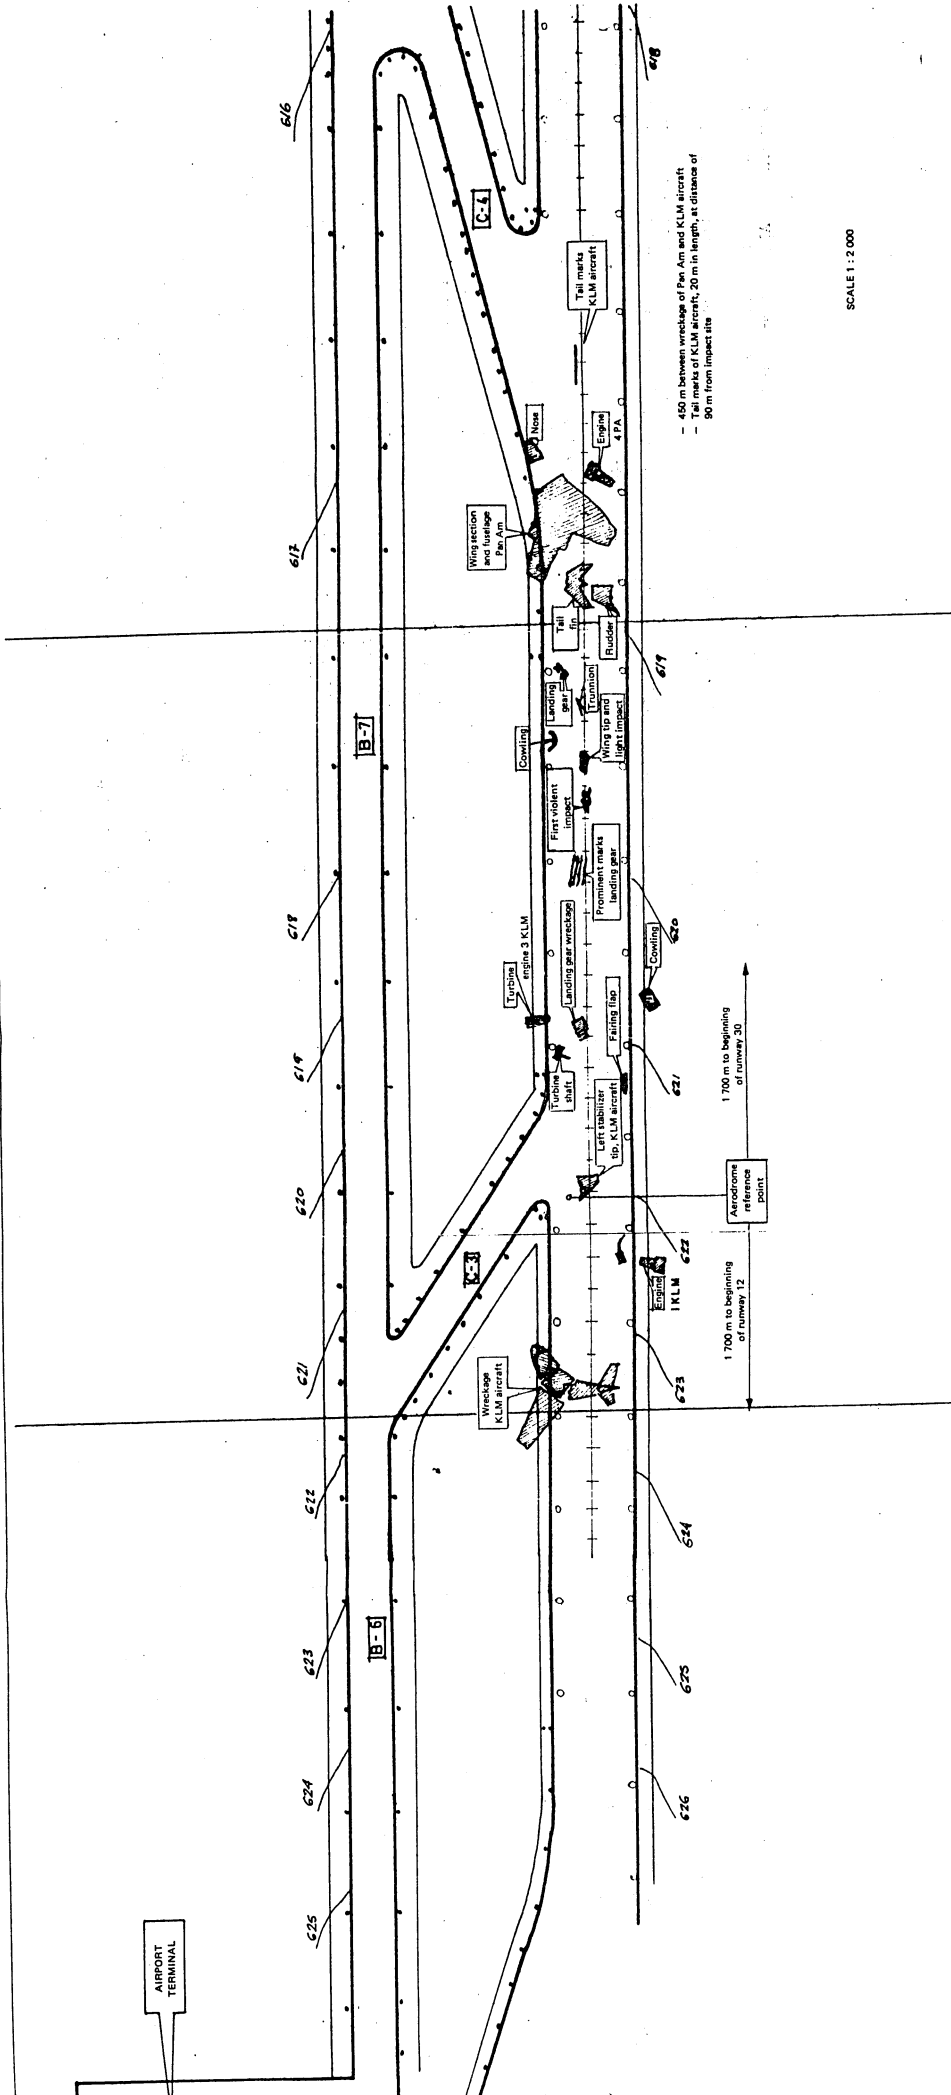
SCALE 1:2 000

- 450 m between wreckage of Ples Am and KLM aircraft  
 - Tail marks of KLM aircraft, 20 m in length, at distance of 90 m from impact site
